Grade-reducing features in timber products

Nathan Kotlarewski, Michael Lee and Gregory Nolan

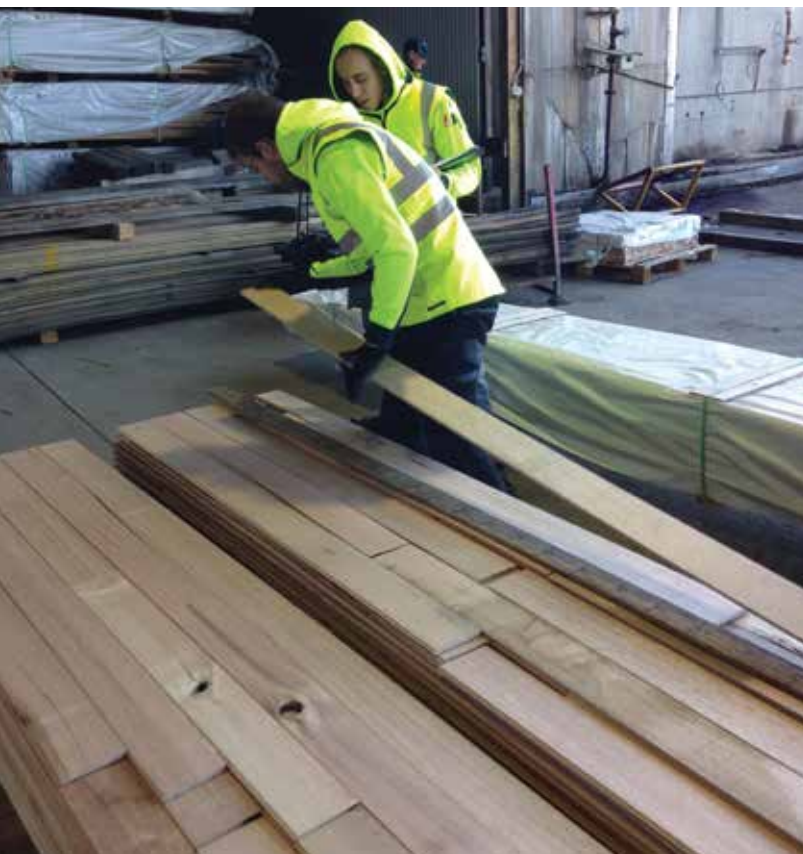
Board assessment and collecting data – feature type and quantity

Every board from two packs of Tasmanian oak hardwood flooring was visually examined and its characteristics noted. The data collected included the quantity of different features in each single board. This was collated into the total type and quantity of features found in this study.

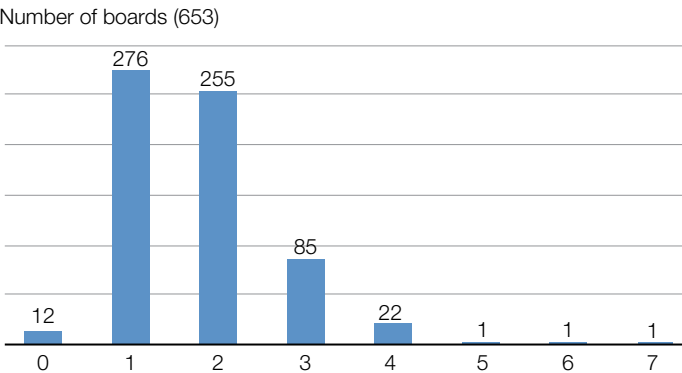
Figure 1: Quantity of grade-reducing features identified in individual boards

Sixteen different features – 10 avoidable processing-induced and six natural – were identified in 653 finished processed floor boards. Highlighted in Figure 1, individual boards typically had one or a combination of two grade-reducing features. Surprisingly only one board had a combination of five, six and seven features. The type and quantity of features found in all the boards is shown in Figure 2. Most of the grade-reducing features

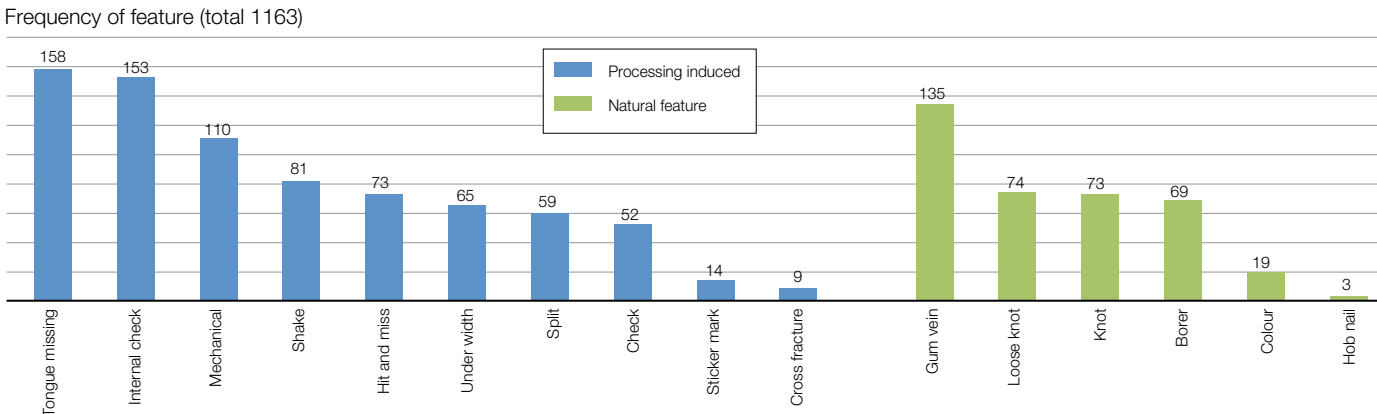
Figure 2: Type and quantity of grade-reducing features

present were a combination of processing-induced features: tongue missing (14%), internal check (13%), mechanical damage (9%), shake from felling (7%), hit and miss (6%), under width (6%), split (5%), check (4%), sticker mark (1%) and mechanically-induced cross fractures (1%). This accounted for 67% of all grade-reducing features. The remaining 33% consisted of typical natural features found in the Eucalyptus species.

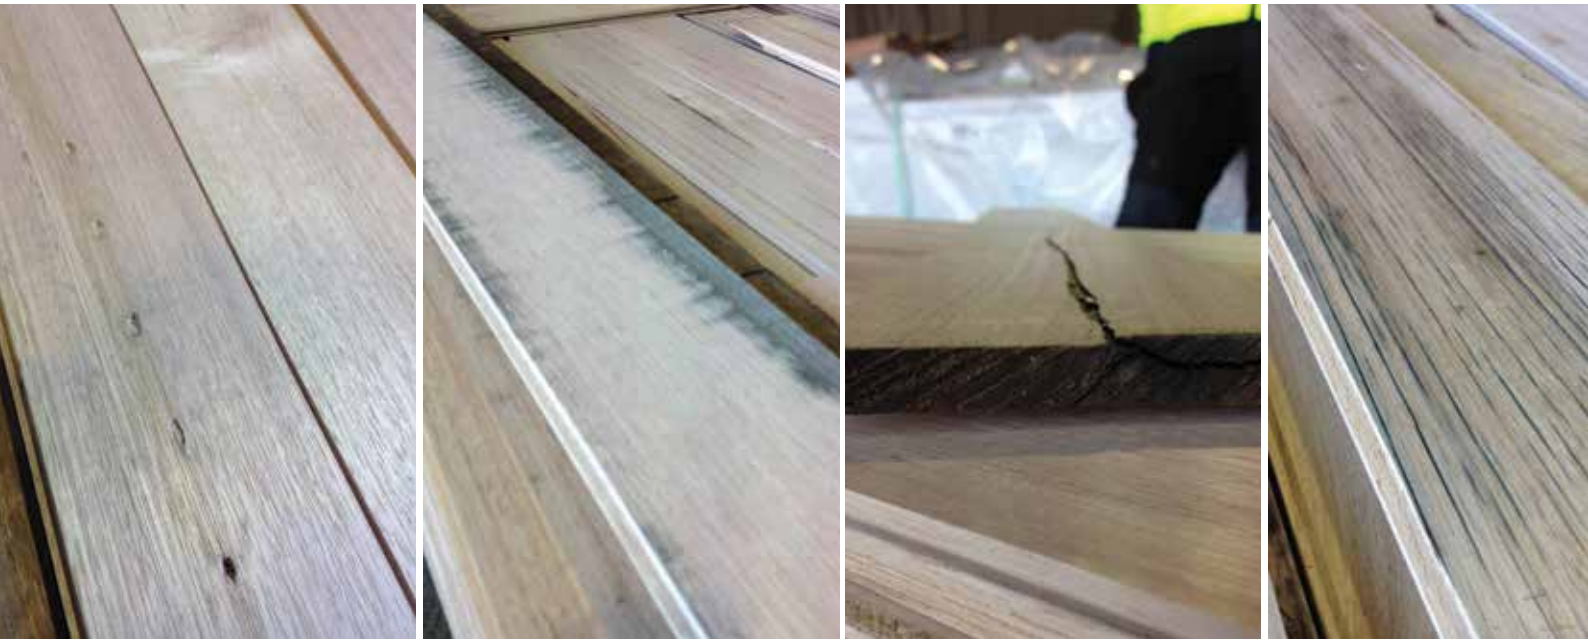
Processing-induced features – mechanical, hit and miss, split and check

A problem with processing-induced features is that most appear at the end of production, but are potentially avoidable if their existence is acknowledged and the cause actively addressed (see photos at the top of page 35). For example, the presence of processing-induced features (such as tongue missing and under width) is an indication of several possible scenarios.

In the first scenario, boards sawn from logs are cut too narrow or the shrinkage rate has been too high, and after drying and processing are unsuitable for the type of profile chosen for that particular timber product. Another scenario is that too much material was removed from the width of the board when it was squared during profile processing and therefore the tongue and groove profile was not properly cut. In another scenario, the hit and miss feature (face skip) could result from unrecoverable collapse (common in Australian Eucalyptus) after inadequate reconditioning of dry boards, or excessive collapse resulting from the drying technique starting at the green mill.

As identified by Innes (1996), significant board collapse can be managed (if not avoided) through proper drying regimes, as can issues like internal checking and surface checks, whereas end splits can be managed in the handling and processing of logs. Finally, proper product handling and care can prevent mechanical damage and sticker marks throughout the production cycle. Note that these scenarios about the presence of features are possible explanations and are not the definitive cause for each feature’s existence.

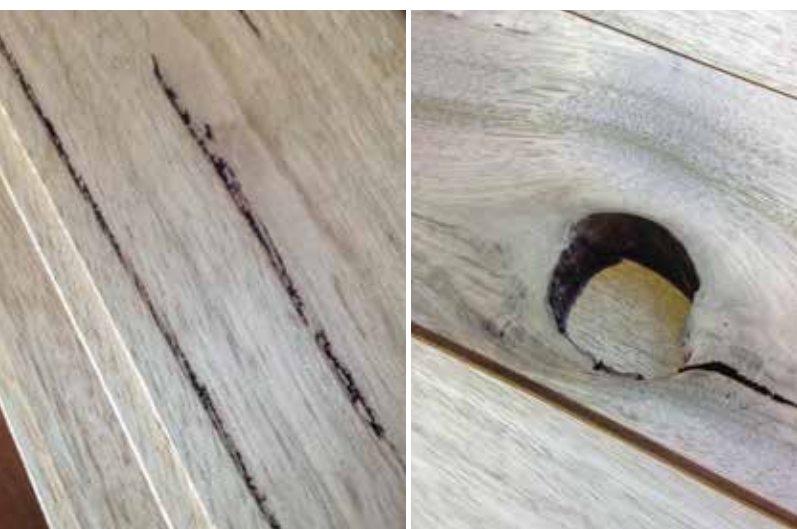
Natural features – gum vein and loose knot

Natural features, as shown in the photos at the bottom of page 35, are generally unavoidable and require management and appropriate allocation of board to timber products that can accept the presence of natural features, either in appearance products or non-visual products. Natural features such as gum vein and loose knots can be identified early in board production. If green boards are categorised in a group with similar obvious features, more cost-efficient processing decisions can be made to manage and stream the product with natural features. This avoids lower product recovery and additional handling if they are mixed with the general product pool, and allows for separate marketing strategies to be developed for high feature materials.
